Walkabout Summary

Walkabout date: June 3, 2013

Location: Glen Allen Elementary School
Richmond Virginia

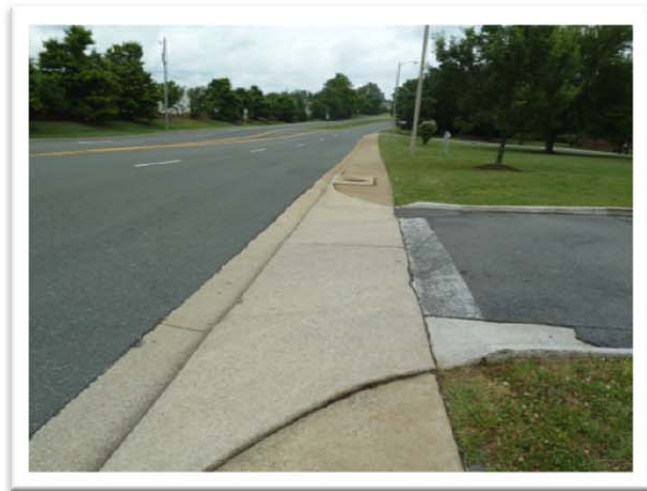
No sidewalks present on Mill Road (A)

The school is sited on Mill Road and every student travels along or across this road as part of their route to school. This is also the main route in and out of the neighborhood and provides direct access to Mountain Road. The walkabout participants noted that during peak morning and afternoon travel times, this road experiences relatively high traffic volumes. There is a segment of sidewalk directly in front of the school, but it only serves students coming from Mill Place Drive.

Sidewalks are only present on Mill Road in front of the school" (looking north)

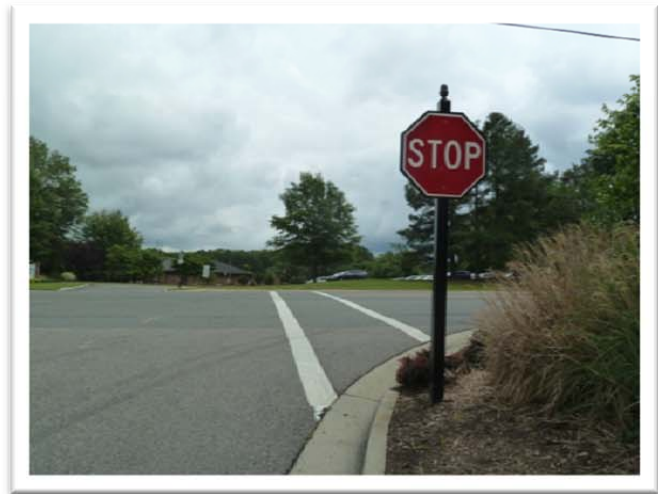
Crossing Mill Road is challenging (B)

The single marked crosswalk along the possible walking routes is located on the southern leg of the intersection with Mill Place Drive and Mill Road. The striping pattern is two parallel bars, reducing its visibility to both pedestrians and motorists. There are school crossing signs placed in advance of the marked crosswalk in either direction on Mill Road, but there are no signs located at the crossing to make it more visible to motorists. This crosswalk lines up with the sidewalks on the school property. Neither side of the crossing has curb ramps and therefore do not meet American with Disabilities Act requirements.

Marked crosswalk across Mill Road at Mill Place Drive (looking east)

Additionally, there is no paved queuing space on the west side of Mill Road for pedestrians waiting to cross. Mill Road experiences relatively high traffic volumes during student travel times, with limited spacing for student pedestrians to cross. Walkabout participants also noted that a crossing guard is not present during student travel time to assist with students attempting to cross Mill Road.

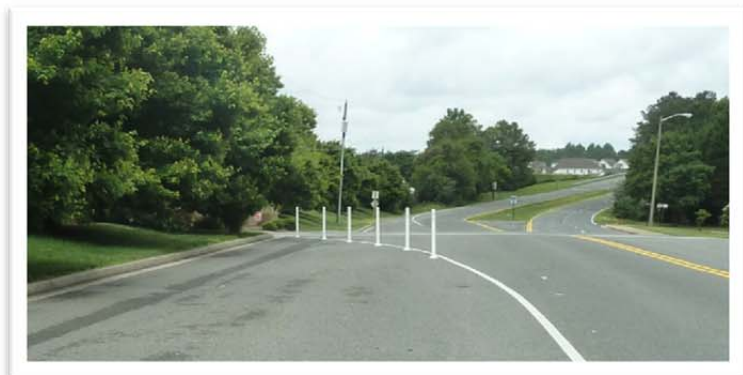
Flexible bollards were installed on Mill Road to discourage motorists traveling southbound on Mill Road from passing drivers in a parking lane (looking north)

Because of the volume of commuters and family vehicles trying to drop off their children in the morning, Mill Road becomes congested. Mill Road is one lane wide in each direction, and parents driving southbound, turning left into the parking lot create a long line of cars waiting to get through to Mountain Road. To discourage motorists from making potentially dangerous maneuvers around other motorists waiting to turn left into the parking lot, Henrico County installed flexible bollards on the southwest corner of Mill Road and Mill Place Drive. During the observation the team noticed (and filmed) drivers darting around cars waiting to make a left turn. This is the same location where students would be crossing the street if they were walking from Mill Place Drive.

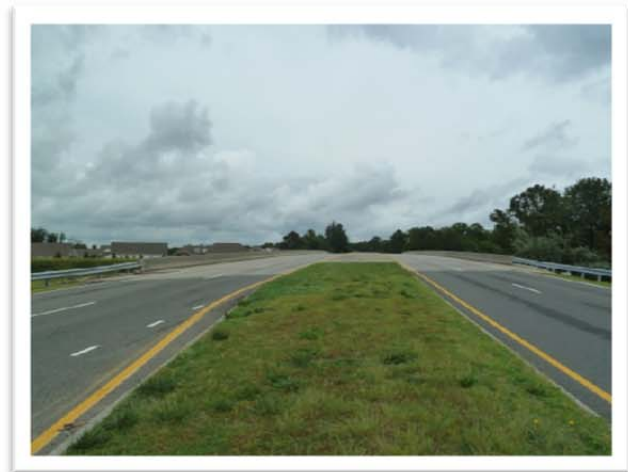
Interstate 295 creates a barrier for walking and biking to school (C)

Several students who attend Glen Allen Elementary School live north of Interstate 295, which is approximately 900ft from the school. Mill Road forms an overpass that crossed Interstate 295, but there are no sidewalks along the overpass. The 5ft shoulders located on both sides of the overpass lack either grade-separation or a vertical barrier (e.g., a railing). The lack of pedestrian facilities along Mill Road and across Interstate 295 keeps students from being able to

Mill Road overpass over Interstate 295 (looking north)
